Manhole Inspection Summary

Manhole # S55C__028MH

Insp Date: **6/23/08 9:34 AM**

Location Address: **rear 3532 ester place**

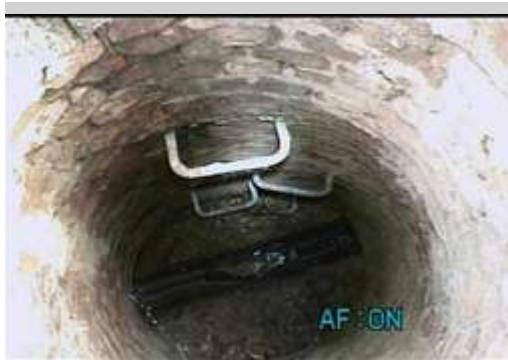
Miscellaneous

steps

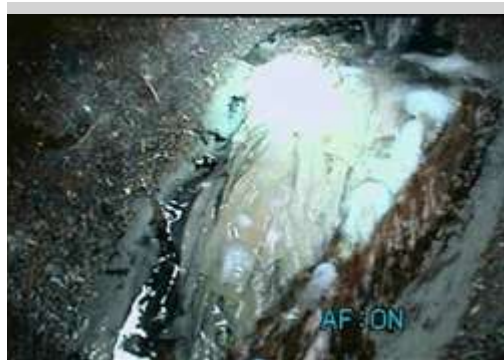
Defect 5

channel debris

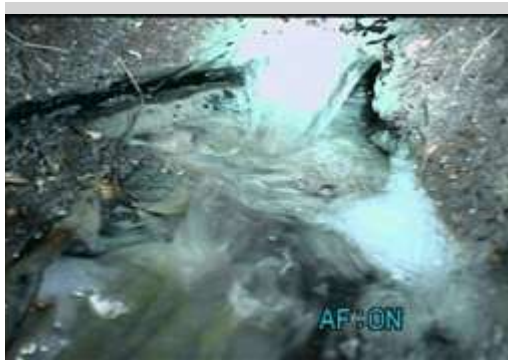
Defect 4

Comments **There is a hole in th channel & alot of debris on the bench**

Condition: ☐ Sound ☒ **Cracked** ☐ Root Intrusion ☐ Deteriorated ☒ **Leaks** ☒ **Debris**

cracked, hole in channel, leaks

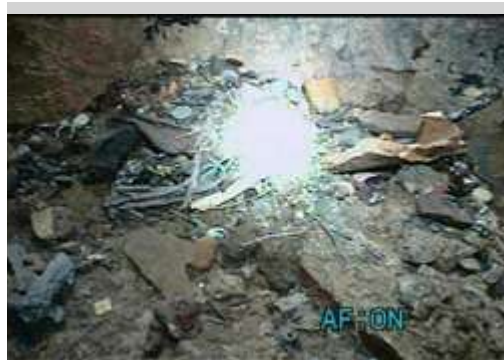
Defect 3

Condition: ☐ Sound ☐ Cracked ☐ Root Intrusion ☐ Deteriorated ☐ Leaks ☒ **Debris**

bench debris

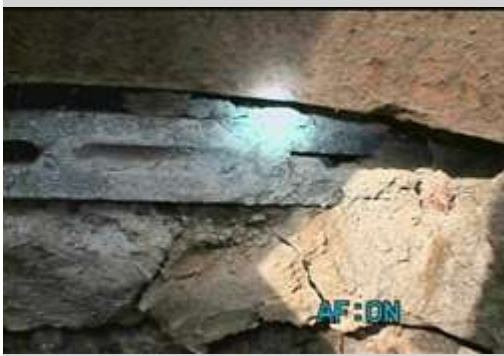
Defect 1

Condition: ☐ Sound ☒ **Cracked** ☐ Root Intrusion ☒ **Loose Brick** ☐ Deteriorated

chimney cracked, loose bricks
